MISCELLANEOUS PAPER SL-80-18

**MONITORING DEFLECTION AT LOCKPORT AND
AT BRANDON ROAD LOCKS
CHICAGO DISTRICT**

MONITORING DEFLECTION AT LOCKPORT AND AT
BRANDON ROAD LOCKS, CHICAGO DISTRICT

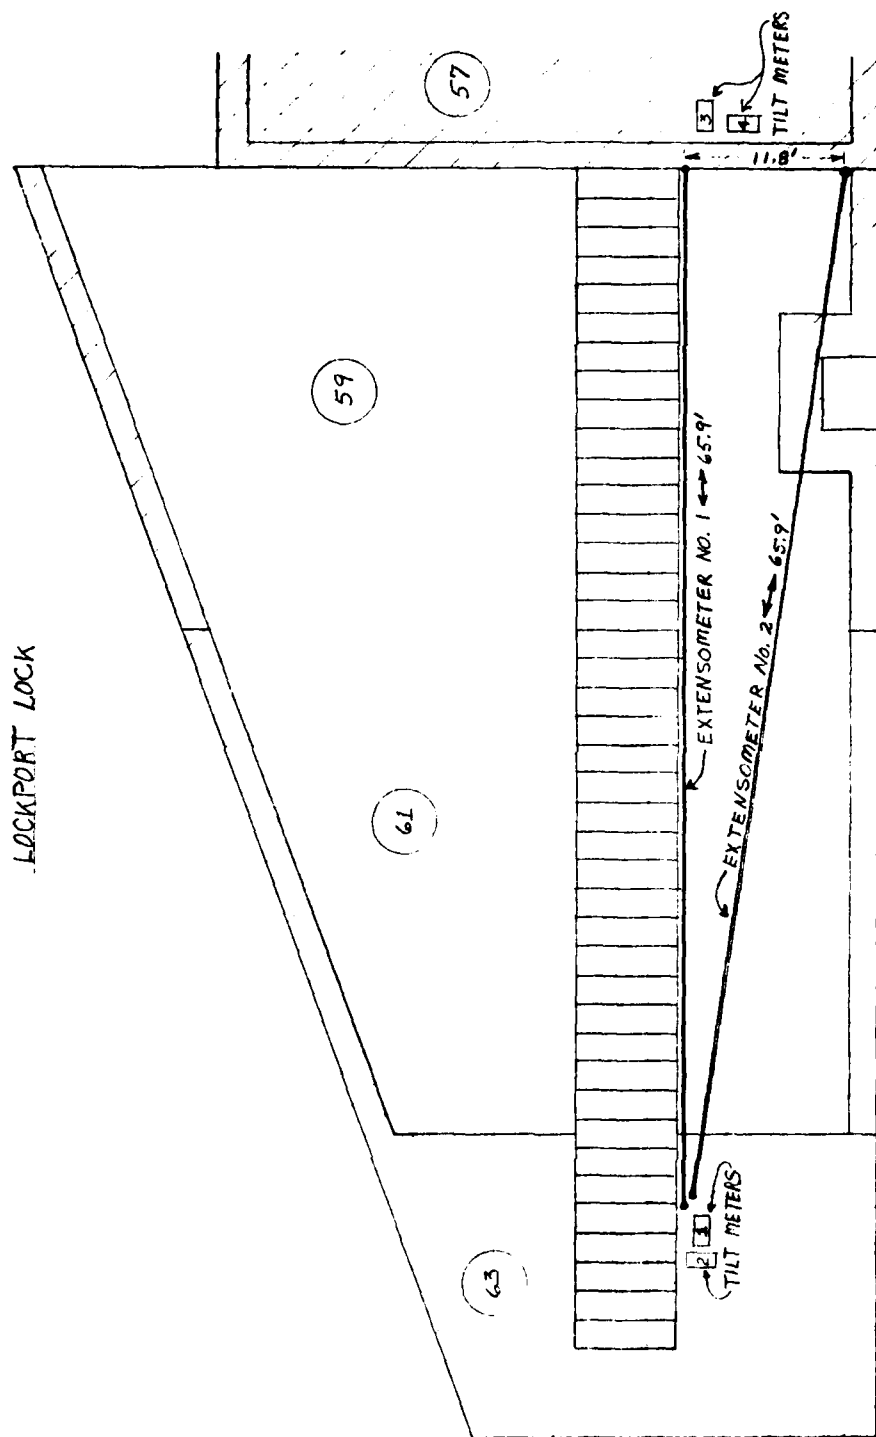
EXTENSOMETER NO'S 1 & 2 BETWEEN MONOLITHS 57 & 63
 FOR MEASURING SEPARATION & LATERAL MOVEMENTS
 & INCLINOMETER NO'S 1, 2, 3, 4 FOR MEASURING TILT
 FIGURE 1

- a. Three extensometers were installed between monoliths 57 and 63 for the purpose of monitoring the movement of 63 with respect to 57. The movement of monolith 63 was referenced to the downstream vertical face of monolith 57. Figure 1 shows the extensometers to monitor downstream (gage No. 1) and lateral (gage No. 2) movements. Figure 2 shows an extensometer to monitor vertical (gage No. 3) movements. The extensometer rods are connected to built-in linear potentiometer for remote electrical read-out.

- b. Two inclinometers (tilt meters) capable of measuring ± 14.5 -deg tilt were installed on monolith 63. One inclinometer was installed with its sensitive axis parallel to the lock wall (meter No. 1) and the other perpendicular to the lock wall (meter No. 2). These meters are fully self-contained and designed to operate from a standard DC power source. Its output is an analog DC signal directly proportional to the sine of the angle of tilt. These meters are shown in Figure 1.

- c. Two inclinometers (meters No. 3 and 4) were also installed on monolith 57 in the same manner as described in b above and are also shown in Figure 1.

8. All gages were monitored for a minimum period of six months. The data has been reduced to plots as shown in the figures. Figure 1 shows the location of extensometers 1 and 2 which measured the axial upstream-downstream movement (No. 1) and lateral movement (No. 2). Figure 1 also shows the locations of tilt meters 1 through 4. Figure 2 shows the location of extensometer 3 mounted along the stairway and anchored at the base of monolith 63 and near the top of monolith 57 to detect any vertical movement.

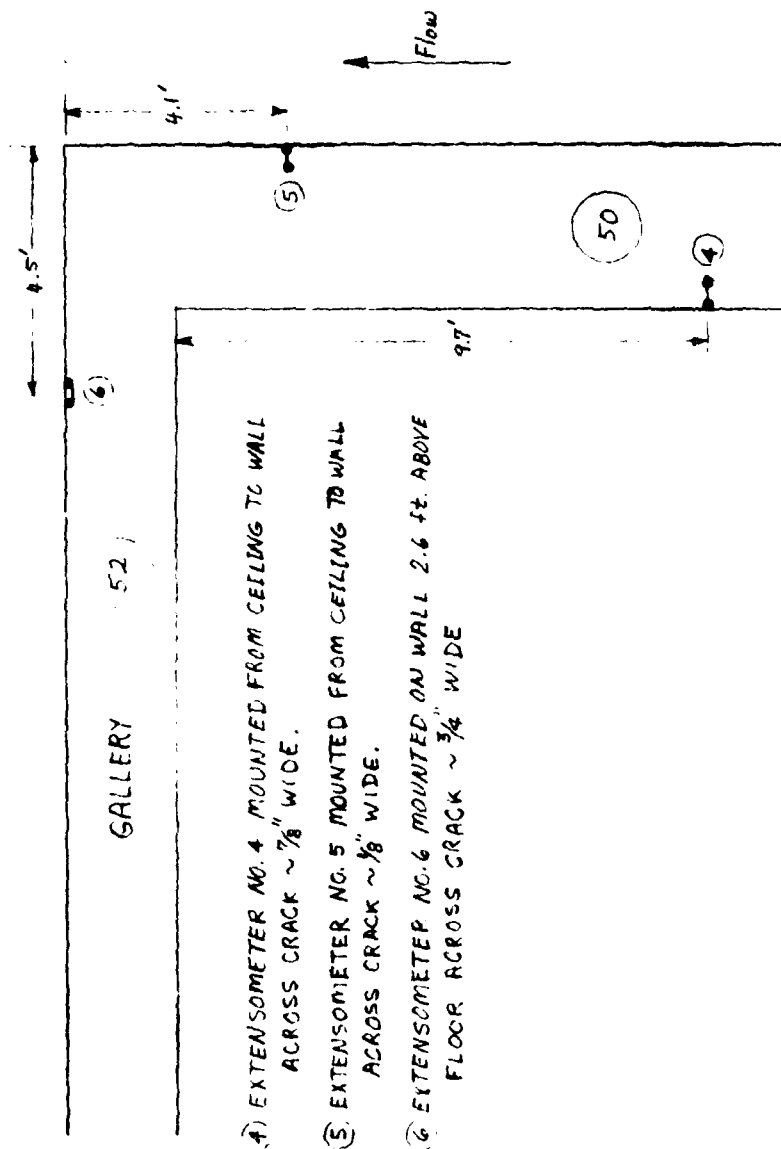
FIGURE 3

- ④ EXTENSOMETER NO. 4 MOUNTED FROM CEILING TO WALL
ACROSS CRACK $\sim \frac{7}{8}$ " WIDE.
- ⑤ EXTENSOMETER NO. 5 MOUNTED FROM CEILING TO WALL
ACROSS CRACK $\sim \frac{1}{8}$ " WIDE.
- ⑥ EXTENSOMETER NO. 6 MOUNTED ON WALL 2.6 ft ABOVE
FLOOR ACROSS CRACK $\sim \frac{3}{4}$ " WIDE

EXTENSOMETER NO'S 4, 5, & 6 MOUNTED IN GALLERY
IN MONOLITHS 50 & 52 FOR MEASURING CRACK WIDTHS

- f. Three extensometers were installed across cracks in the gallery in monolith 50. Figure 3 shows the location of these gages (extensometers 4, 5, and 6) in the gallery. These transducers monitored crack movement directly and were recorded remotely.

12. Extensometers 4, 5, and 6 were located across existing cracks in a gallery as shown in Figure 3. These extensometers were mounted perpendicular to the direction of flow; two in a horizontal plane, and extensometer 5 in a vertical plane to monitor crack opening caused by a portion of the land-side lock wall moving toward the lock chamber. Results are shown on Figures 12, 13, and 14. Extensometer 4 shows a movement of 0.030 in. corresponding to the existing crack

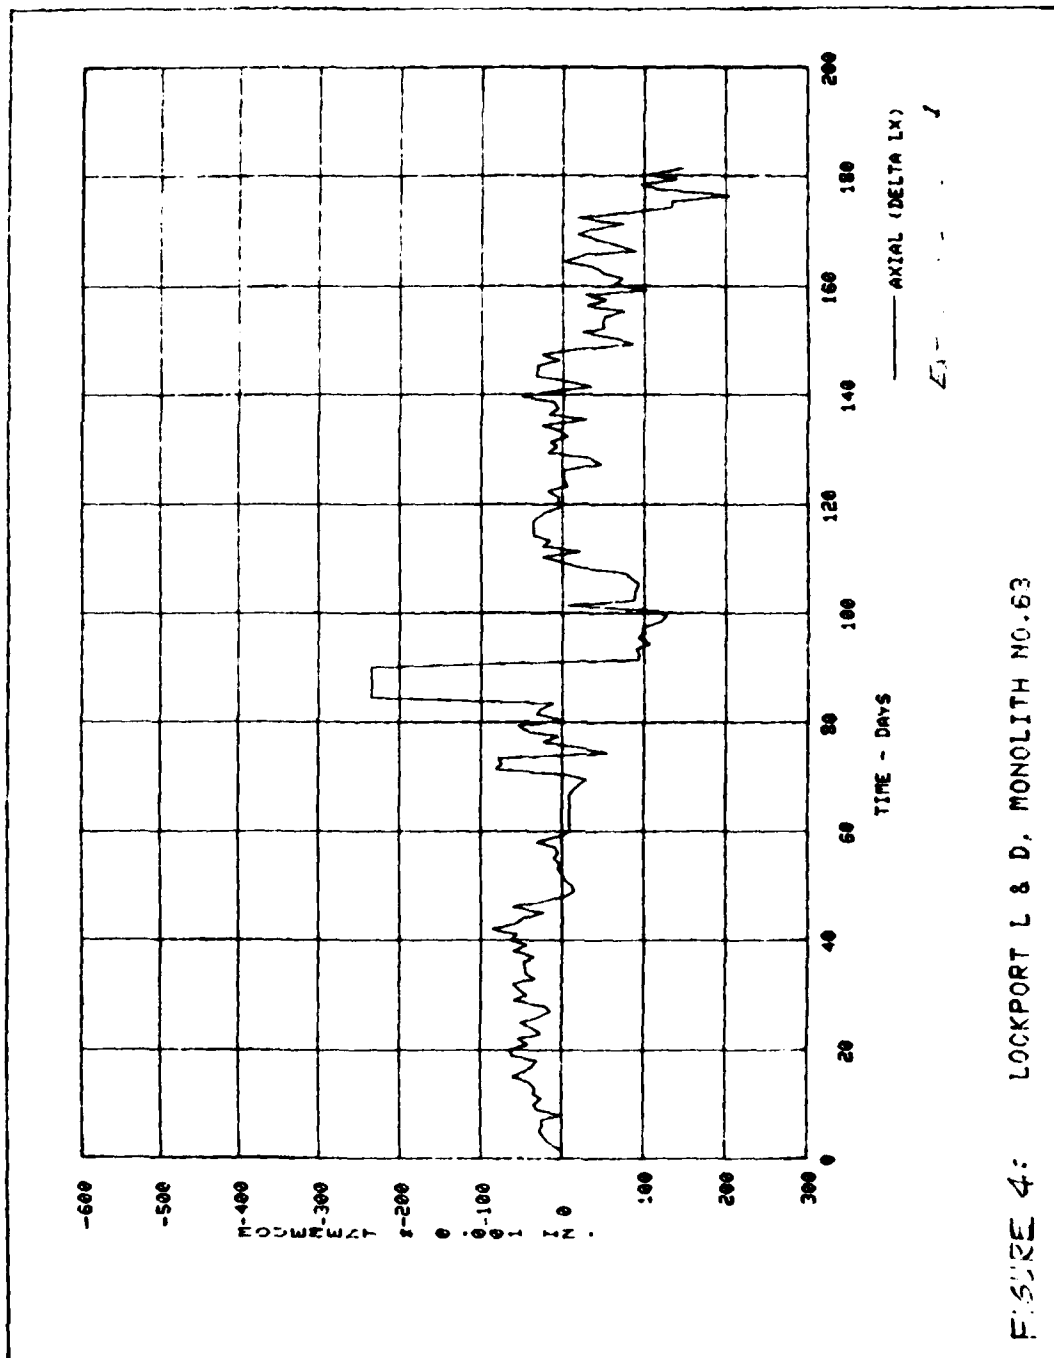
FIGURE 4: LOCKPORT L & D, MONOLITH NO. 63

10. Axial movement of monolith 63 as shown in Figure 4 was ± 0.10 in. with a residual displacement of $+0.10$ in. corresponding to a separation of joint opening of 0.10 in. Lateral movement as shown on Figure 5 amounts to -0.10 in. toward the river side from the centerline of the lock chamber. Figure 6 shows a similar amount of shortening in the vertical direction. Figure 7 shows the temperature recorded on one of the extensometers which was used to make thermal corrections on the extensometer indications.

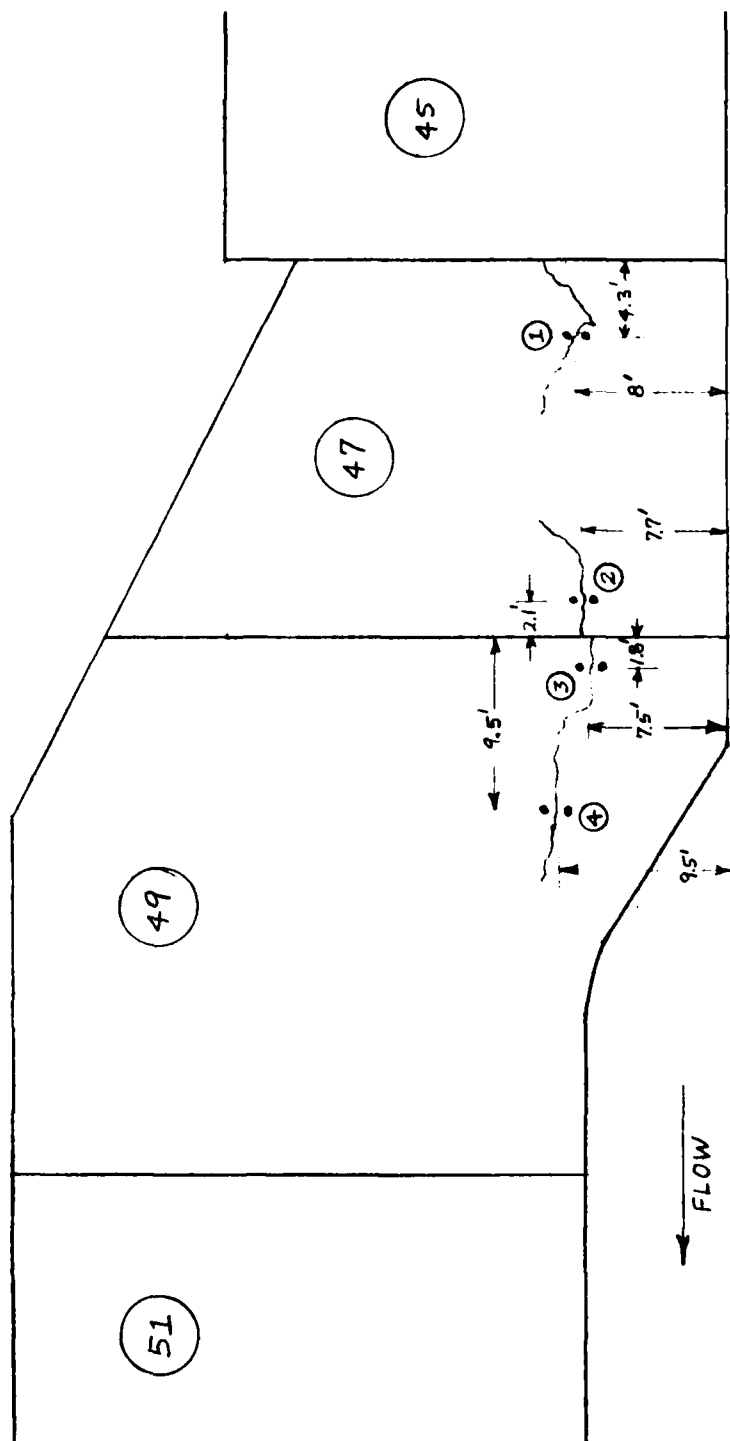
LOCATION OF WHITTEMORE GAGE POINTS 1,2,3,4
FOR MEASURING CRACK WIDTHS
FIGURE 16

13. The fixed gage points installed at Brandon Road Lock located as shown in Figures 16, 17, and 18, were monitored for a period of eight months. These Whittemore gages were placed in 3/8-in. diameter drilled holes in the concrete. Gage inserts were fitted and driven in place. The results of periodic readings are shown in Figures 19 through 30. Points were lost on gage No. 1 after five weeks and were reset at the 27th week. Gage No. 2 shows a crack opening of 0.040 in. and Gage No. 3 shows as much as 0.060 in. A similar trend is indicated for all gages through gage No. 9 except for gage No. 7 which was installed across a monolith joint between monoliths 48 and 50. Gage Nos. 10, 11 and 12 were located across cracks in the ice house as shown in Figure 18 and showed little movement.

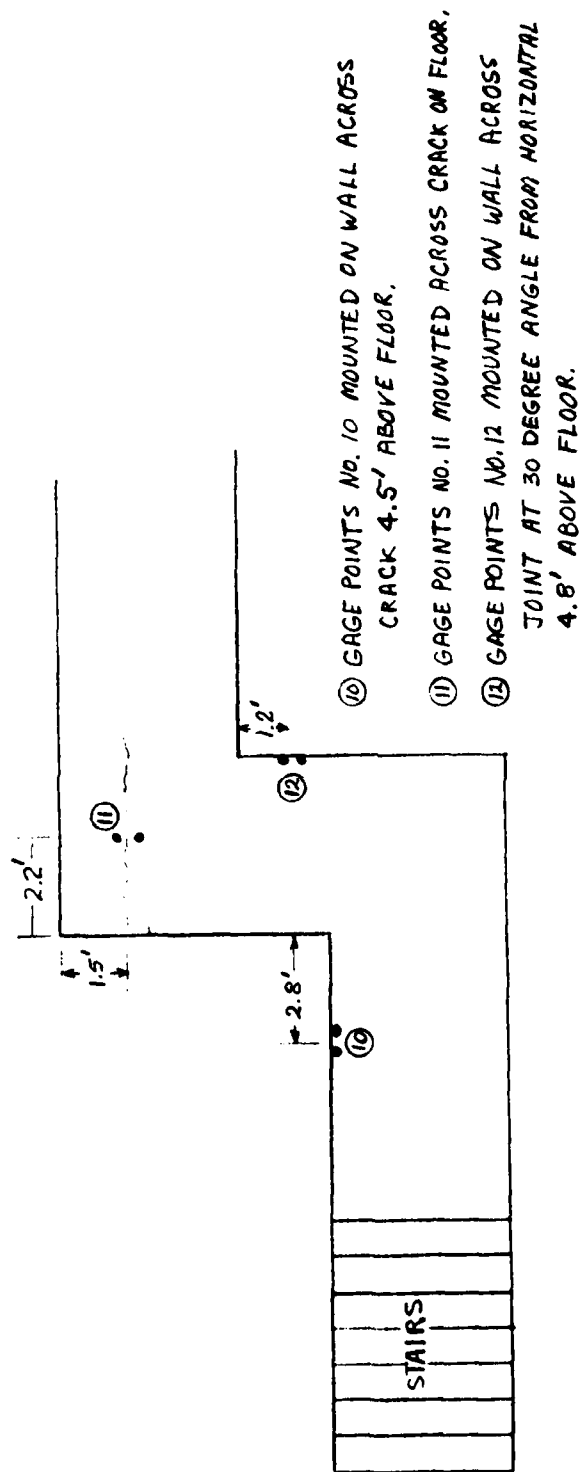
LOCATION OF WHITTEMORE GAGE POINTS 10, 11, & 12
FOR MEASURING CRACK WIDTHS
FIGURE 18

- a. The fixed point data showed all the cracks to be widening a maximum of 0.060 in. and this occurred as the temperature increased during the later half of the monitoring period.
- b. Gage points 10, 11, and 12 located across cracks in the ice house at Brandon Road showed very little movement during this monitoring period.
